# Land and Water

# Modifying Traditional Stream Stabilization Techniques Based on Project Needs

Tweaking the traditional design tool box

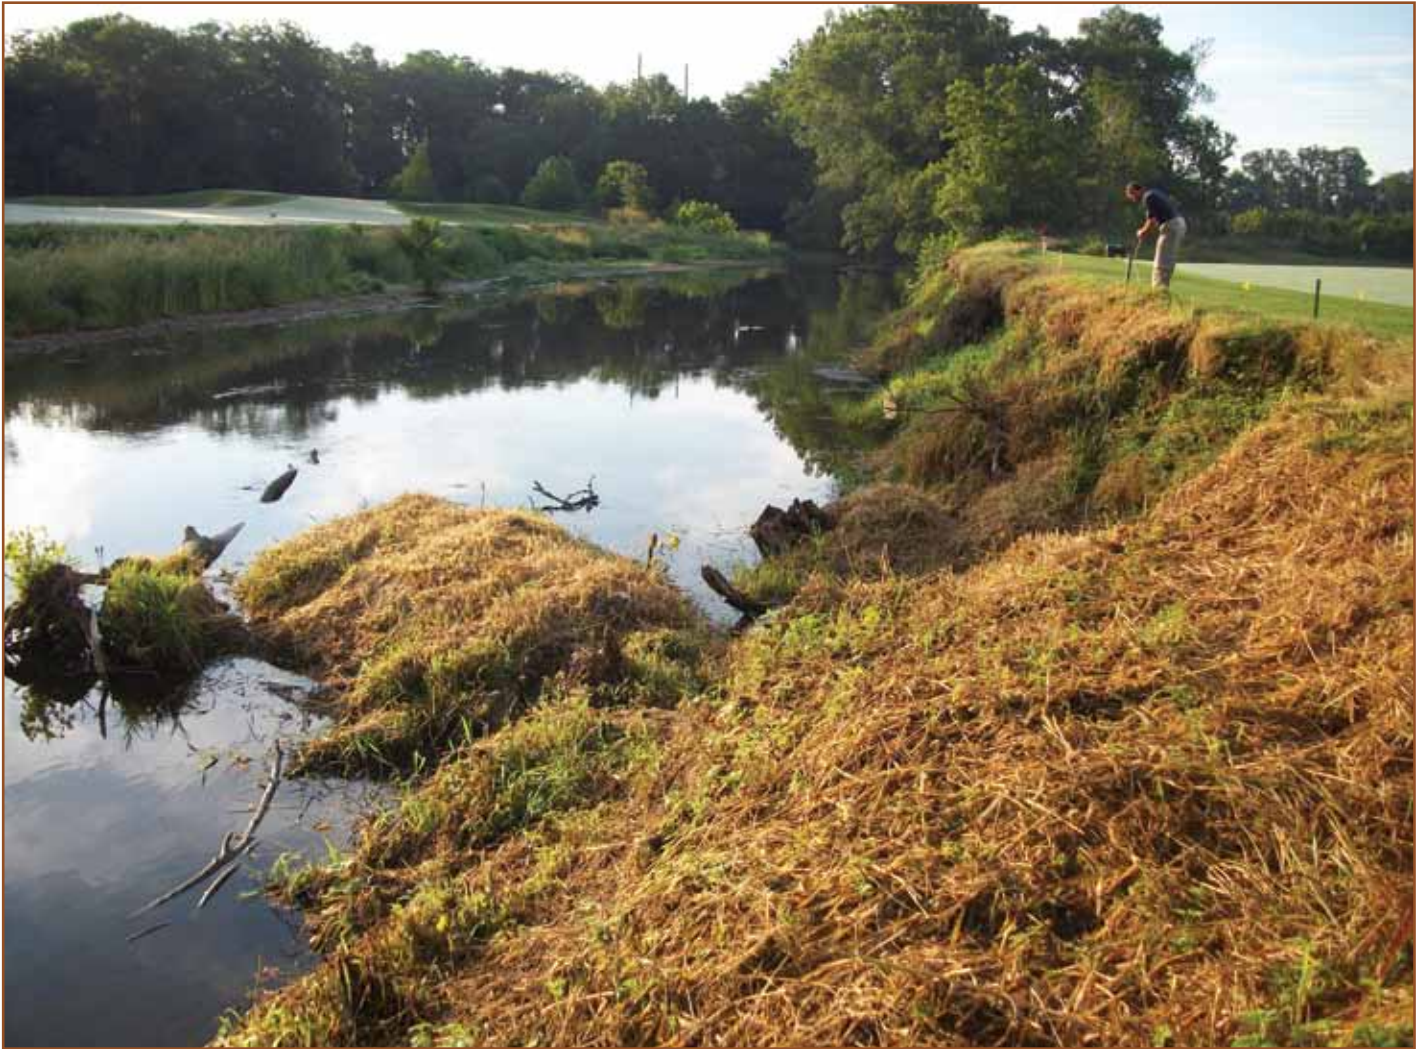
**Stream bank at the start of the project, demonstrating severe high bank erosion, undercutting and slumping as well as invasive vegetation.**

During a high flow period, a large log became lodged into the bank at a downstream angle. The log eventually collected other large debris and began directing storm flow energy into the down gradient bank. Over a short number of months, more than 300 feet of stream bank had been eroded. At certain locations the bank erosion went 10 feet deep into the bank, creating a safety hazard and fairway hazard at the adjacent golf hole.

The identified causes consisted of the log jam and storm flows. The symptoms consisted of severe bank scouring, undercutting, and slumping.

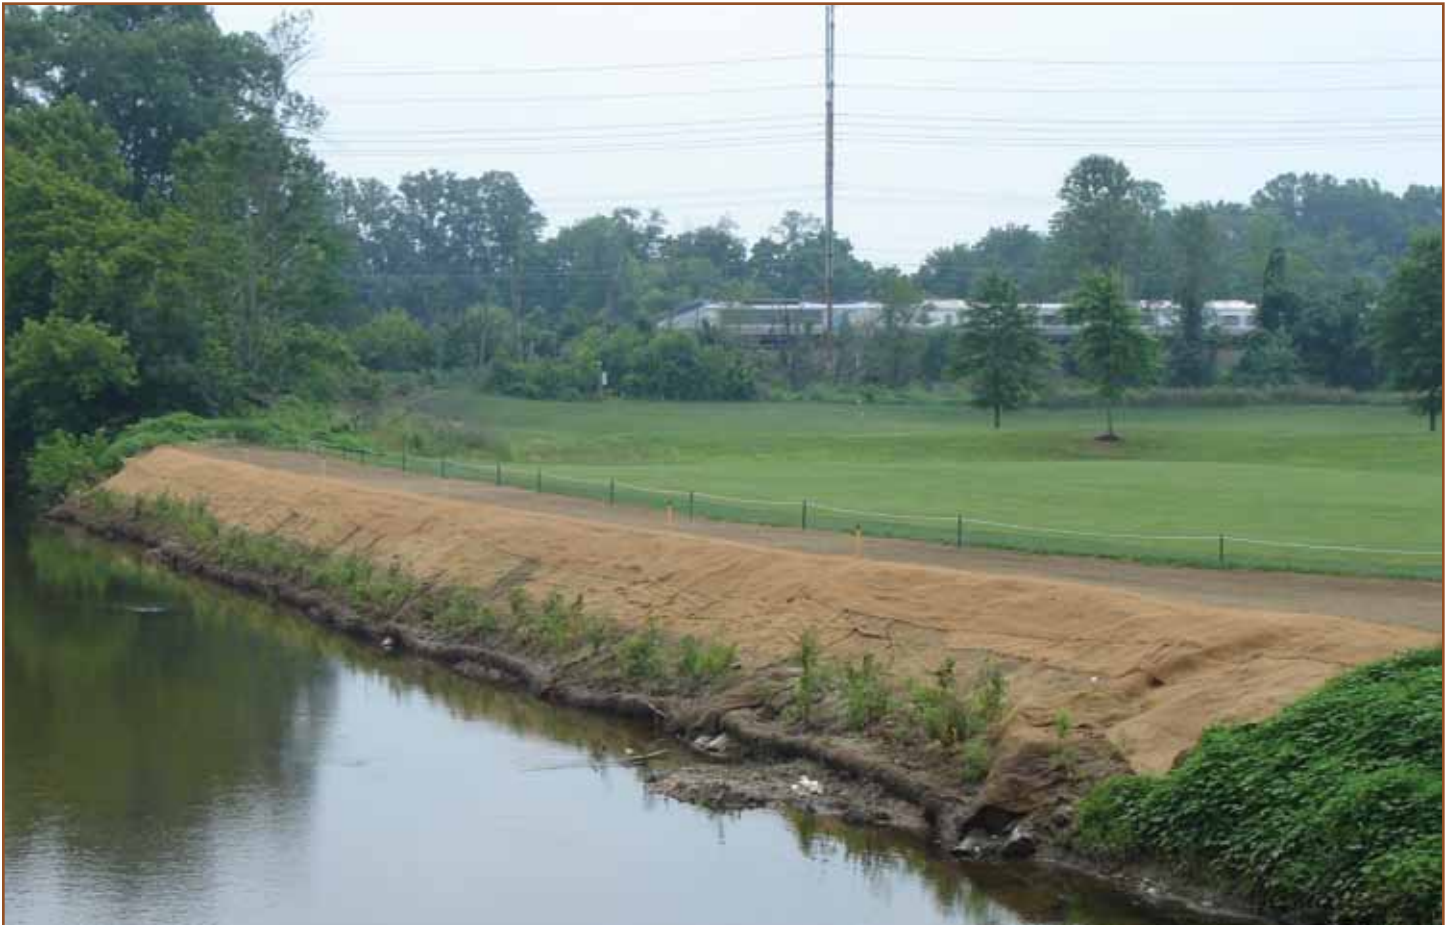
**The final piece of the design was to maintain a stable toe of bank using a combination of coir fiber logs, low growing shrubs and a heavy jute mat (same area as photo on page 8).**

Stunted logs vanes are able to be placed at much steeper angles along the bank and are embedded just below the bank surface. These vanes also provide stability along the entire height of the bank, providing structure during a range of storm events. The final piece of the design was to maintain a stable toe of bank. A combination of coir fiber logs (short-term toe protection) and low growing shrubs (long term protection) were chosen for this application. Since the height of woody vegetation could not extend beyond the top of bank, the shrubs were planted at the toe of the slope so, at maturity, the tops of the shrubs would be level with the top of bank.

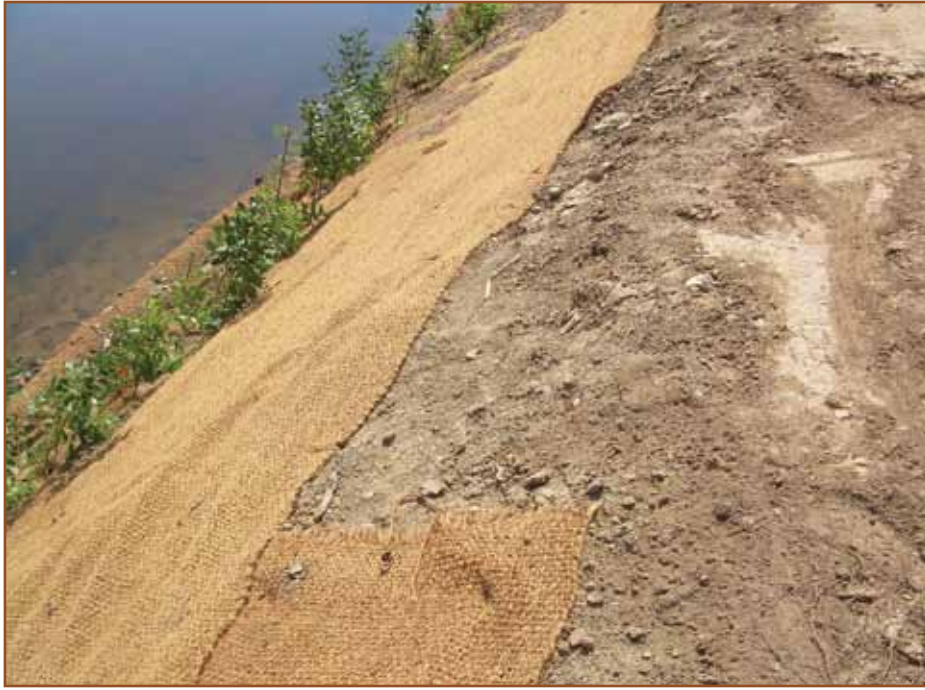
A closer view of the jute mat, which was seeded and stapled down.

the coir fiber logs were set at the base flow elevation. A heavy jute mat was anchored behind the coir fiber logs and soil was backfilled in lifts between the vanes. A lift of top soil was placed along the slope and the disturbed area was seeded with a native perennial rye mix and a wildflower mix. Once seeded, the jute mat covered the bank and was stapled down. At the toe of the slope, the openings were cut in the jute mat to enable the shrubs to be planted.

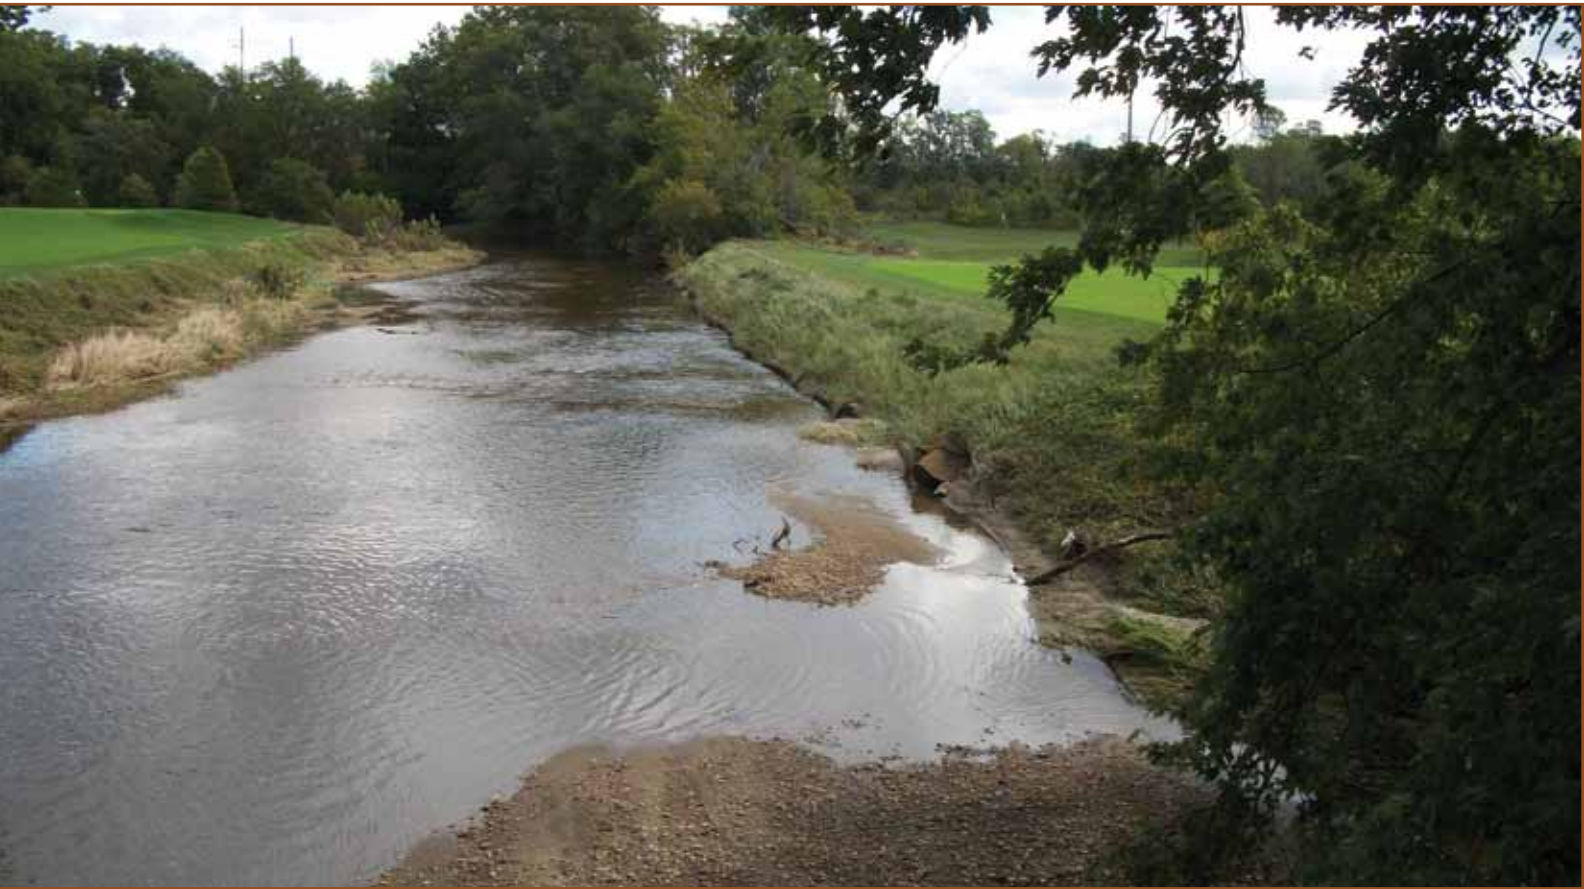
**Two months after project completion, a 7.5 inch storm event resulted in over bank flooding. The entire bank was under two feet of water for nearly 36 hours.**

During the first week in October, approximately two months following the completion of the project, a severe 7.5-inch rainfall event occurred, representing a worse case scenario test. The golf course experienced the worst flooding in its history. The site was under nearly two feet (over bank) of flood water for more than a day. When the flood receded, the project was completely intact.

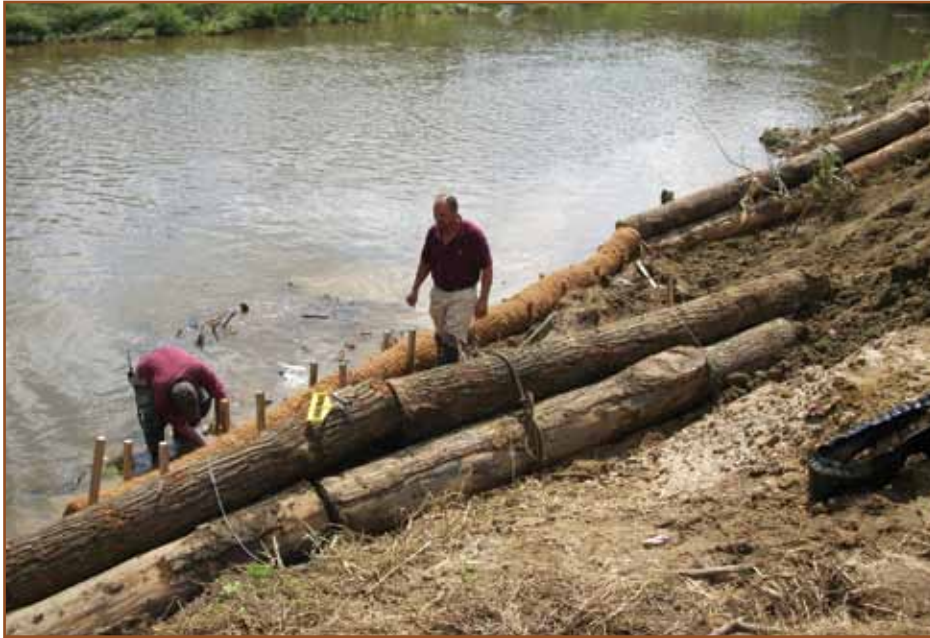
**Placement of stunted log vanes and bank toeing (the bank structure) that was covered with lifts of soil.**

Sizing of the stunted logs was a significant consideration. Due to access for materials and equipment and the need to work between the creek and the ten to 15-foot wide fairway corridor, the design employed 12 to 15-inch diameter logs in ten-foot lengths. The logs were bound and anchored in triads to form large stunted vanes.

As the vanes were set and anchored,
